CONDITION REPORT

St Anne's Church Hall,  
Parsonspool  
DUNBAR

Report Date : 08 June 2016

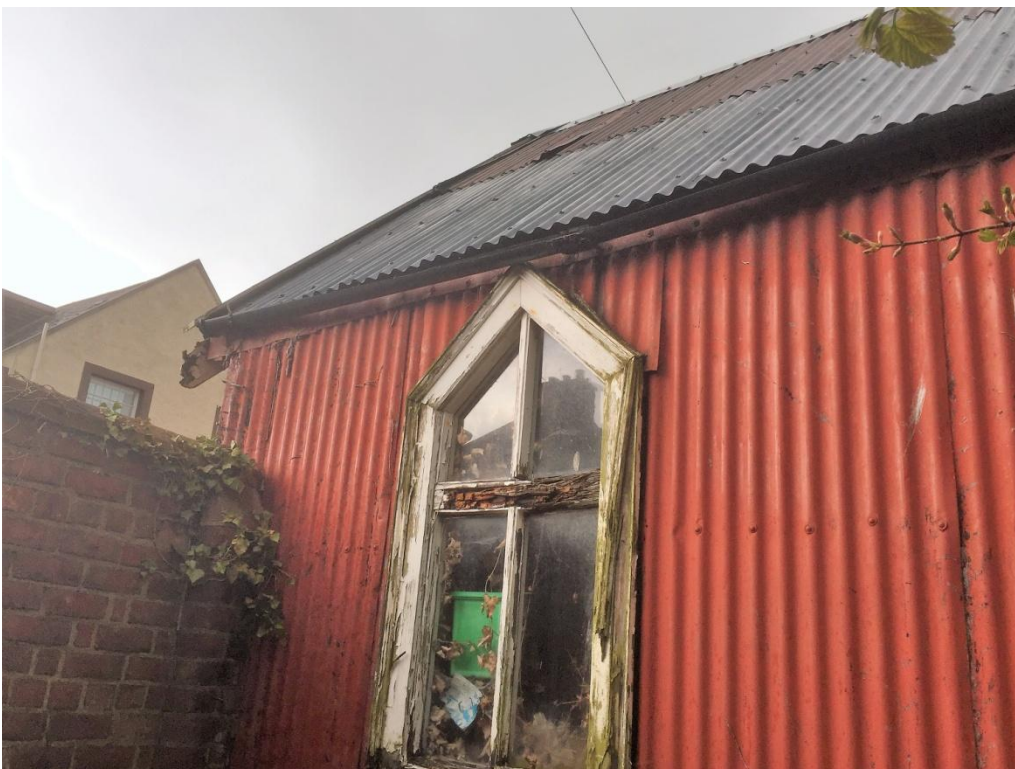
- 3.5 The windows are now rotted, to the extent that wholesale replacement is required. The glazing is also broken and vandalised. The doors and fascia timbers are also rotted and require replacement.

Rotted Window Timbers

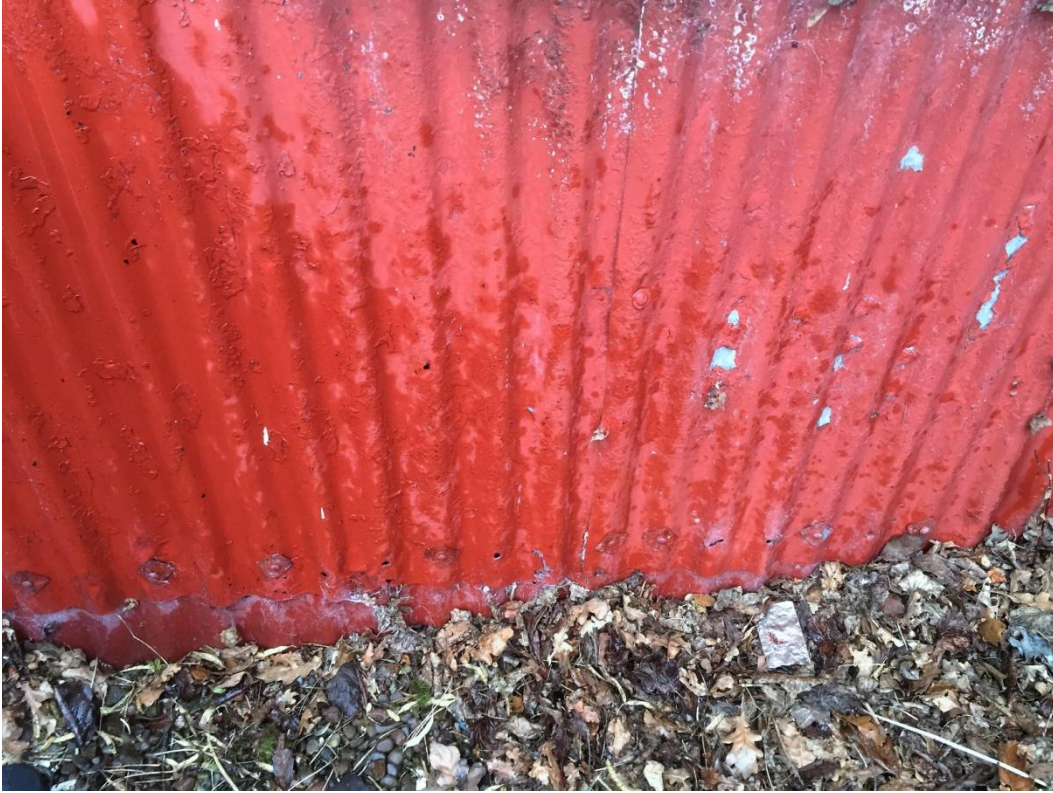
- 3.2 Sections of the original profiled metal roof have been replaced, as the original metal has rusted and corroded beyond its useful life.
- 3.3 Further sections of the roof covering, along with the majority of the sections of external wall cladding, are now also showing signs of corrosion and will require replacement if water penetration is to be avoided.

Holed and Corroded Metal Cladding

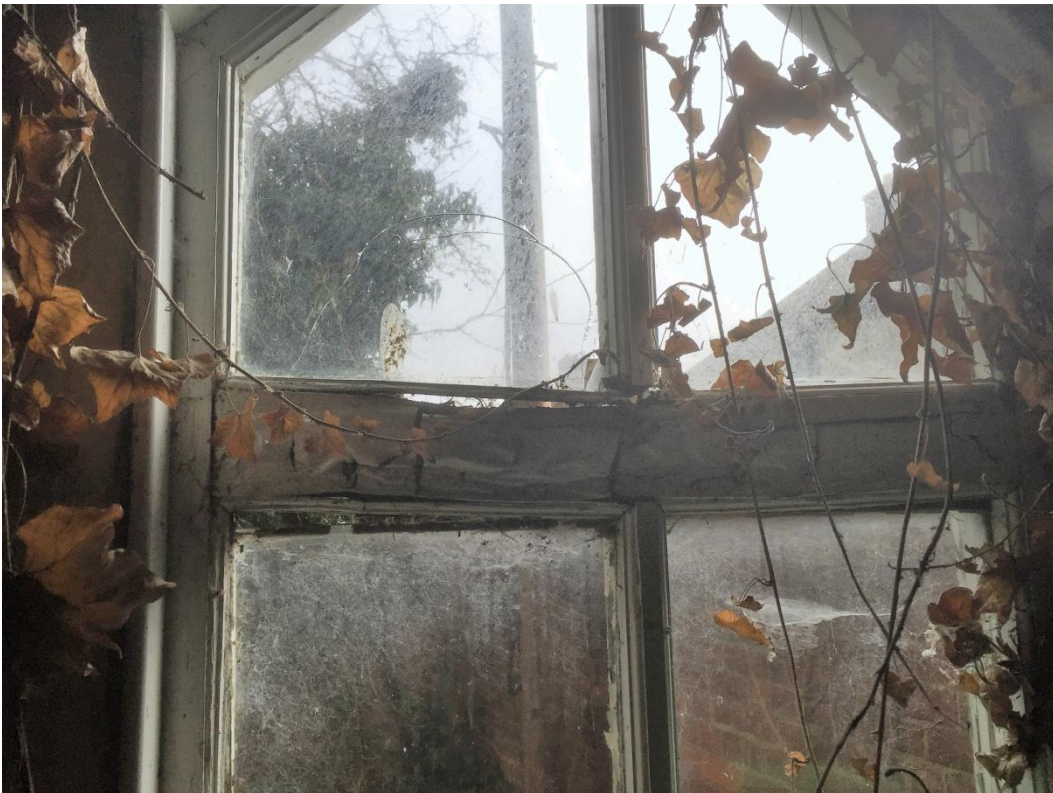
- 3.6 Internally the condition of the elements of the building are also in poor condition. Vegetation growth is beginning to become established within the building, entering the property through gaps in the cladding and through broken and rotted windows.

Vegetation growth within building and rot affecting window timbers internally

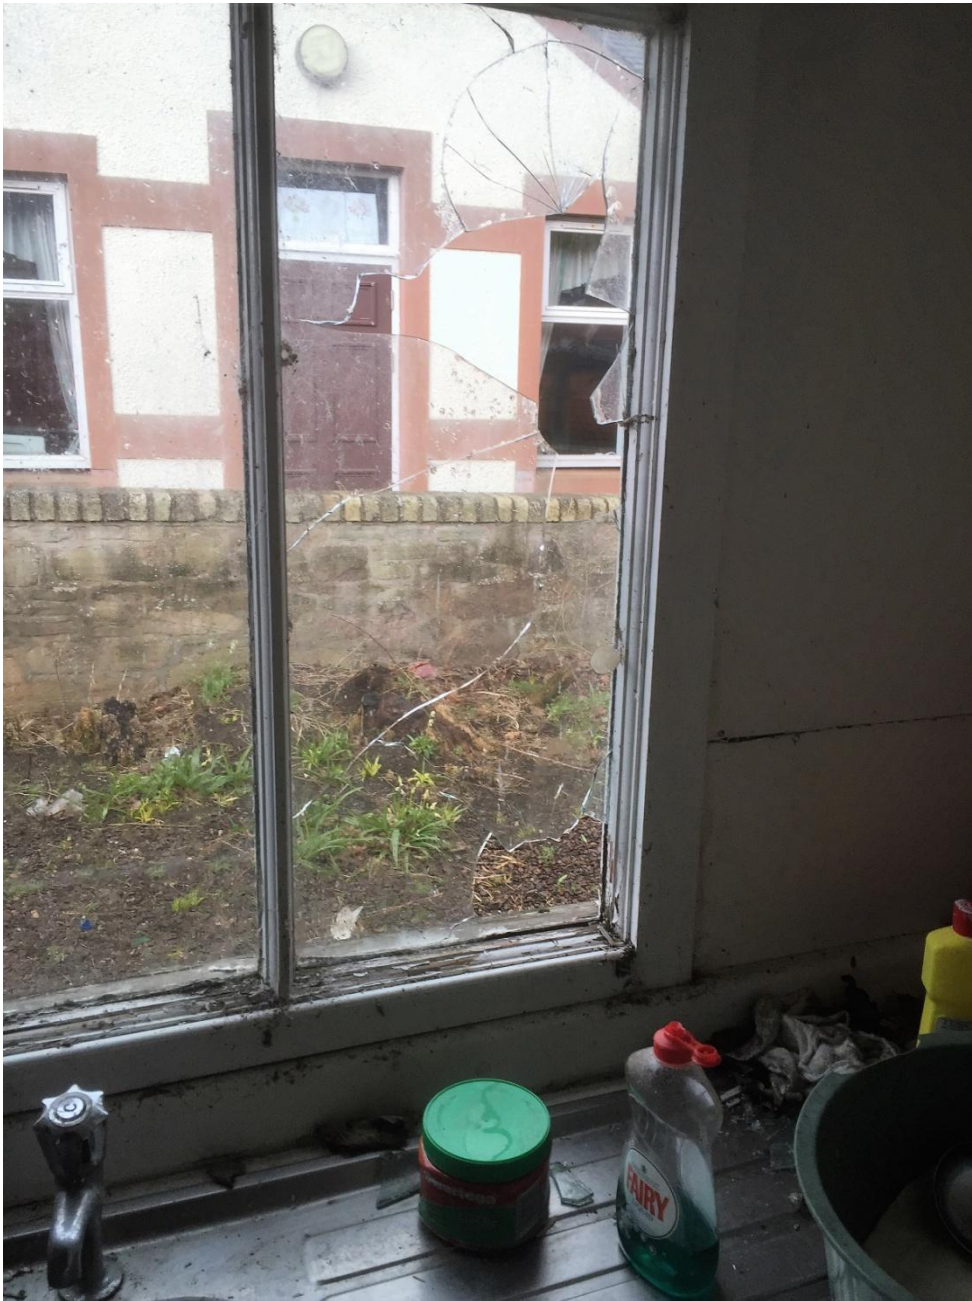
Broken Glazing
