# INFORM

INFORMATION FOR HISTORIC BUILDING OWNERS

## Pantiles Maintaining a Pantiled Roof

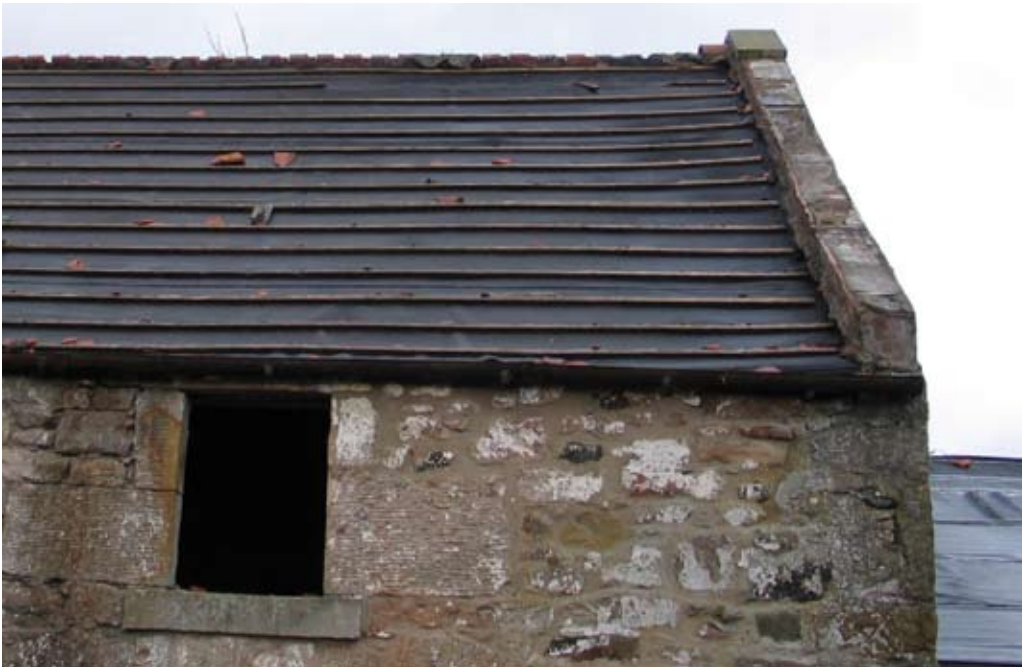
*An exposed roof showing battens onto which pantiles are hung by their nibs*

A pantiled roof has a series of regularly spaced horizontal battens attached to the rafters on which the tiles are hung. The tiles have a projecting nib on the back. This small projection on the rear of the tile holds it in position when laid on the batten. The battens needed to be spaced evenly to ensure the tiles maintained the appropriate lap over their underlying neighbour.

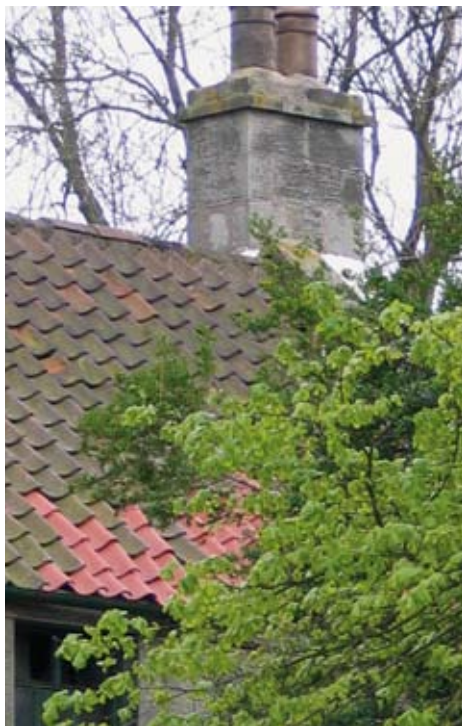
*Replacement pantiles located in an unobtrusive area of the roof*

are still manufactured and may have to be used. Most of these are machine made but this produces regular sizes, shapes and colours which will make the replacements stand out from those already on the roof. When introducing new tiles to an existing roof it is better to try and place these in unobtrusive areas to avoid the visual impact of new against old and by relocating the existing tiles to the more conspicuous areas of the roof.

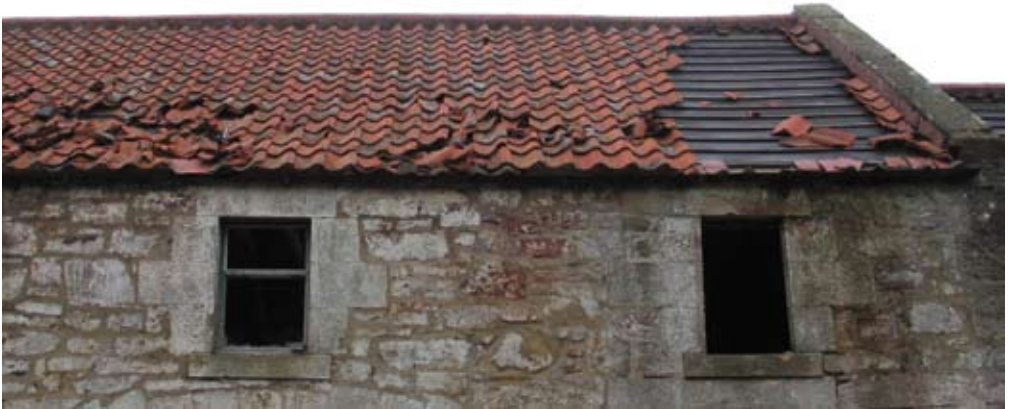
Structural problems make this pantiled roof vulnerable to further deterioration

Movement in the structure of the roof can lead to the deterioration of battens and fixings. This can dislodge the alignment of the tiles and make the roof vulnerable to water penetration. Where this is a problem the roof structure should be fully inspected to establish, and rectify, the cause. Filling the open junctions between the tiles with lime

mortar can help stabilise loose tiles and keep them in place. The use of foam or bituminous-type treatments on the internal and external tile surfaces is not advised. These applications make it hard to re-use tiles in the future and can, by reducing ventilation, also hasten timber decay.
