# INFORM

INFORMATION FOR HISTORIC BUILDING OWNERS

## Indent Repairs to Sandstone Ashlar Masonry

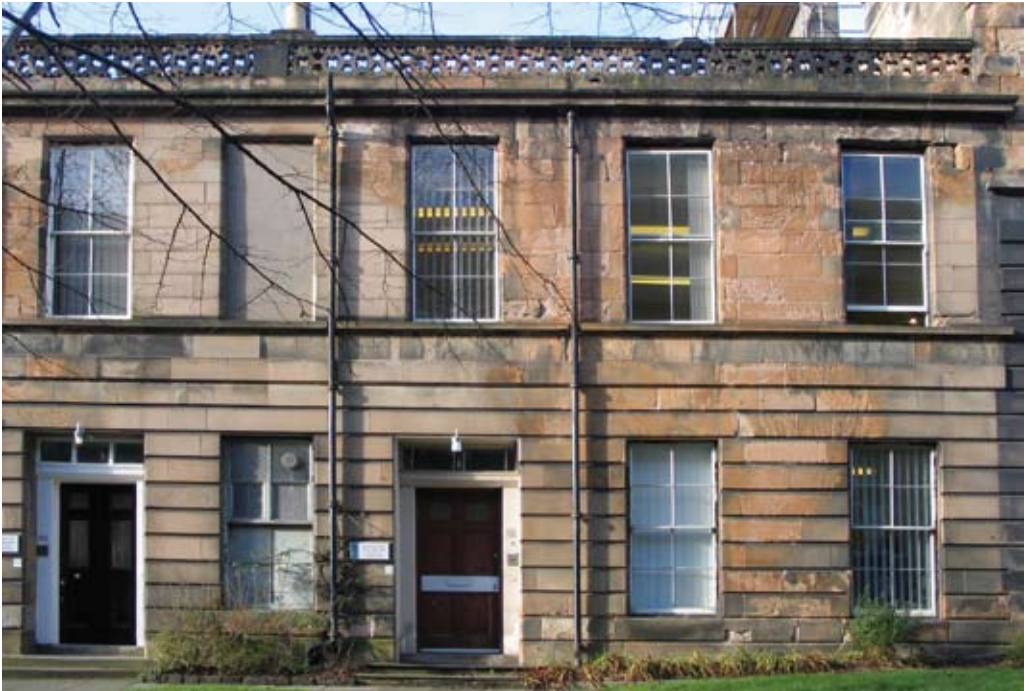
When nature was ignored, the performance of sandstone was less effective. This is particularly found where ashlar block walls were built “on cant”, with the geological bedding set vertically, rather than horizontally. When “face bedded” in this way the stone’s strength is not used to advantage, and the outer faces of the stones become prone to failure through a process know

as delamination. This effect can trigger the need for a considerable degree of indent work, as the characteristic failure of the bedding planes can lead to the complete loss of the exposed face across a building's elevation. Fortunately, it is more usual to find buildings constructed in the appropriate manner, with only a few individual stone blocks ever requiring attention.
