# INFORM

INFORMATION FOR HISTORIC BUILDING OWNERS

## The Maintenance of Cast Iron Rainwater Goods

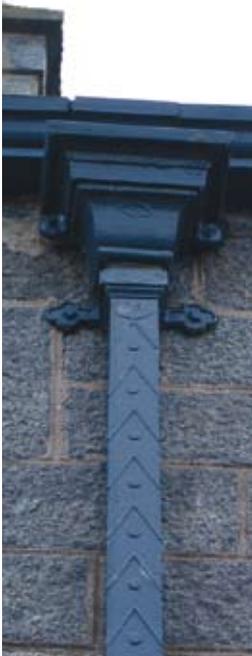
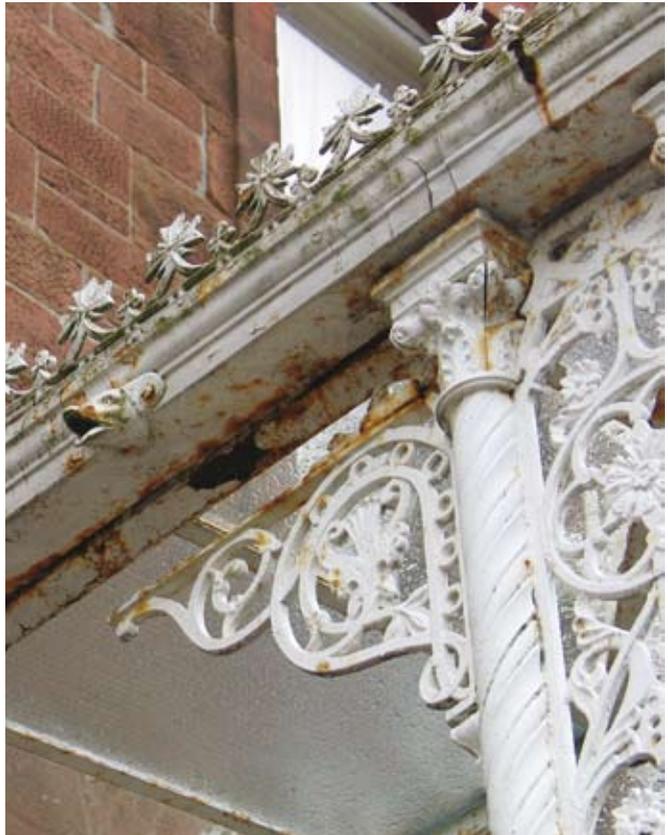
also offered a popular medium for additional architectural embellishment. Hopper heads were frequently enriched with ornamentation (as were downpipes occasionally), and gutter brackets provided an additional opportunity for decorative designs.

Nineteenth century Scottish cast iron manufacturers were world leaders in the production of cast iron items and their many illustrated catalogues featured extensive selections and choices. A great variety of hopper head, gutter and gutter bracket designs still survive and it is often possible to identify the name of the original manufacturer by their marks on the surviving pieces.

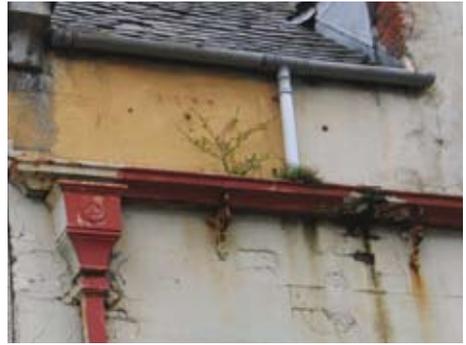
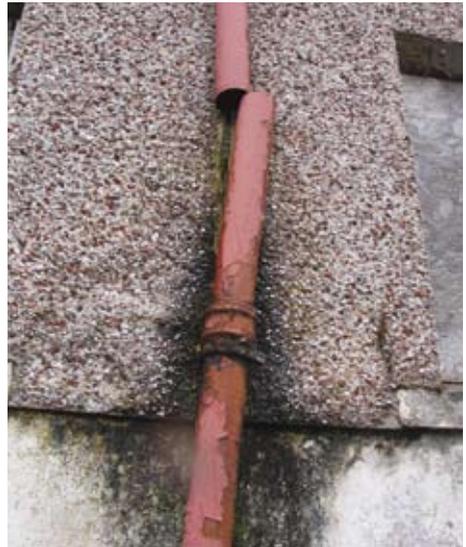
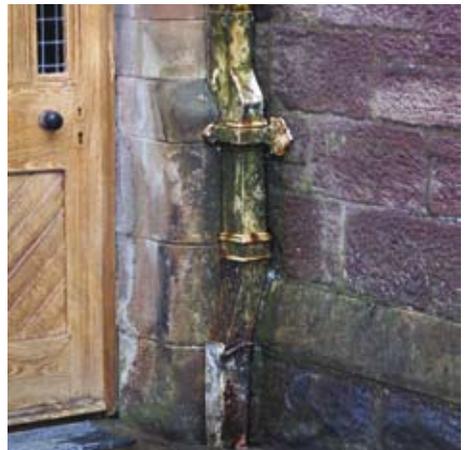
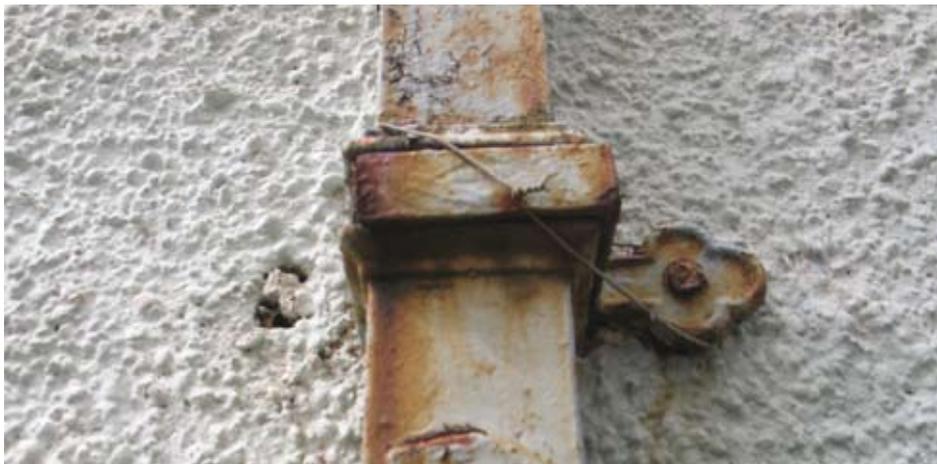
**Corrosion** – Infrequent painting, or painting that misses inaccessible areas such as the rear of pipes and hoppers, can make cast iron sections and their fixings vulnerable to corrosion. This can go unnoticed for some time. Badly sealed, leaking joints are particularly prone to further corrosion and deterioration.

**Misalignment of components** – The misalignment of components, such as broken sections of drainpipes or gutters, eliminates their effectiveness. This can be caused where fixings or holder-batts (collars that are fixed to the wall on either side of the drainpipe to secure it in place) have not been maintained and have become loose. Where supporting gutter brackets or rhone hooks have been lost, they should be replaced before the gutter sections become dislodged and damaged.

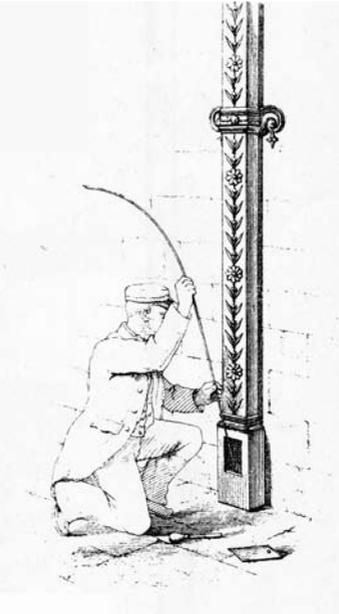
Where downpipes are missing, existing gutter outlets will usually indicate where original downpipes were located. Replacement downpipes should be fixed away from the wall to facilitate repainting and to allow any

leaking water to run down the back of the pipe rather than down the wall. Gutter brackets or rhone hooks should be re-used where possible.
